Experimental and analytical investigation of dynamic crack patterns in automotive windshield sheets subjected to low velocity impact

In this study, some drop ball tests in different impact energy levels are conducted in order to monitor fracture behavior of an off-road automotive windshield. Also dynamic crack patterns of laminated glasses are examined based on the impact energy levels and impact conditions. In addition, the acceleration which is imposed to impactor during the accident is recorded. The experimental results are compared to an analytical approach regarding the resultant impact force as well. There is a good agreement between the impact forces of experimental test results and analytical approaches ones. All in all, in low velocity impacts, impact energy releases through powdering region in impact area, radial cracks and strain energy in PVB. It is concluded that in lower impact energy levels, the higher impact speed, the more number of radial cracks. In addition, at higher energy levels, number of radial cracks decrease due to higher strain energy levels in PVB interlayer. Therefore, in low velocity impacts, number of radial cracks has reverse relationship with penet

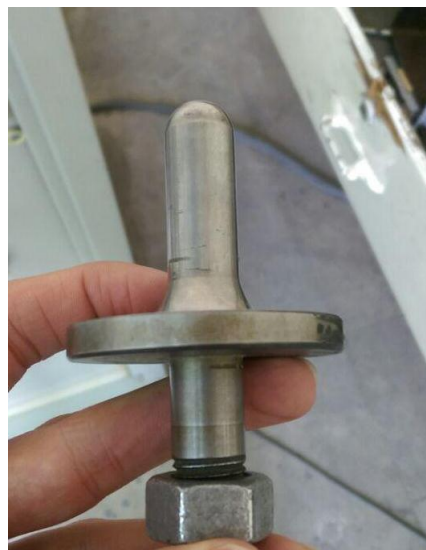
Fig2. Steel imp actor used in drop ball tests

The geometrical and mechanical properties of the impactor (which is depicted in Fig.2) are explained in Table 2.

Geometrical properties	Mechanical properties
Spherical part: Diameter= 16mm	Material: steel
Cylindrical part: Height 45mm	$E= 200\text{GPa}$, $\mu=0.3$

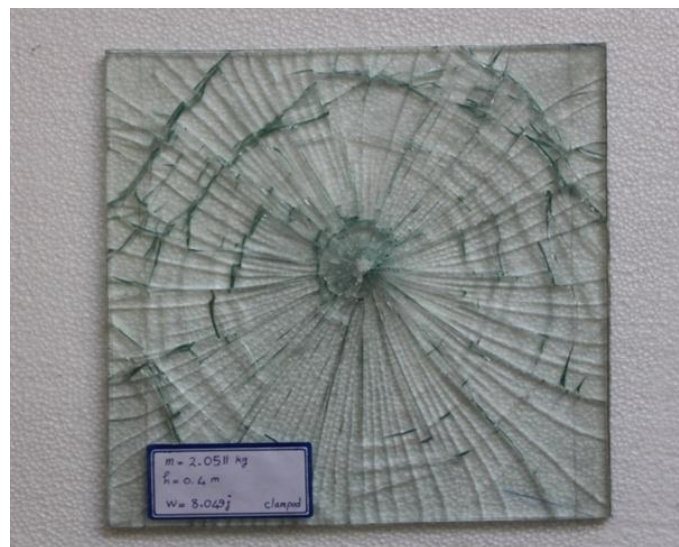
Fig10. .specimen after test code D-B-T-4

Laminated glass specimen after test code D-B-T-4 is shown in Fig.10.

As it is observed from Fig.10, the impact region at the center of specimen (powdering region) is a circle with approximate diameter of 20mm in which cracks density and consequently damage level is higher than the other regions of specimen. The projectile has penetrated to the depth of 1-1.5mm of the laminated glass and due to 2.5mm thickness of glass layers, no elongation has been occurred in PVB interlayer. Although energy level of test code D-B-T-4 is higher than test code D-B-T-3's one, penetration at the center of specimen is less in test code D-B-T-4 which

can be representative of impactor's mass influence. In test code D-B-T-4, the impactor mass is 2.0511kg, while it is 2.0712kg in test code D-B-T-3, therefore it can be concluded that in 2 similar conditions, the less impactor mass, the less penetration depth at the center of specimen.

It is easily seen from test code D-B-T-4 specimen that cracks have initiated from the impact surface and propagated through thickness. In this test, one circumferential crack has been propagated which is at the radius of 95mm from the center. Besides, some sectors of circumferential cracks have been made at the

radiuses of 62, 70 and 80mm from the center of specimen and serve as bridges to connect radial cracks. Also it can be seen from the laminated glass that the radial cracks in test code D-B-T-4 are nearly symmetrical and about 84. After drawing a comparison between test code D-B-T-4 and test code D-B-T-3, it is obvious that radial cracks of test code D-B-T-4 are more than their counterparts in test code test code D-B-T-3, on the other hand circumferential cracks of test code D-B-T-3 are more than test code D-B-T-3's ones. At test code D-B-T-4, distance between radial cracks is shorter than its corresponding item in test code D-B-T-3.

At all 4 sides of specimen which was clamped during the test, diagonal asymmetrical

net shaped cracks have been made which have created some right triangles in margins of the specimen. Diagonal net shaped cracks at the margins of test code D-B-T-4 specimen are more congested in comparison to the whole radial cracks. In addition, at both upper and lower glass layers, radial cracks converge at the center of the specimen and their divergence increases at larger radiuses. The acceleration versus time graph of test code D-B-T-3 is illustrated in Fig.11. As it can be seen from the graph, the maximum acceleration imposed to projectile is 732.0356m/s^2 which is occurred at 0.000131s .
