# Experimental and analytical investigation of dynamic crack patterns in automotive windshield sheets subjected to low velocity impact

Automotive Fluids and Structures Analysis Research Laboratory, School of Automotive Engineering, Iran University of Science and Technology, Tehran 16846-13114, Iran

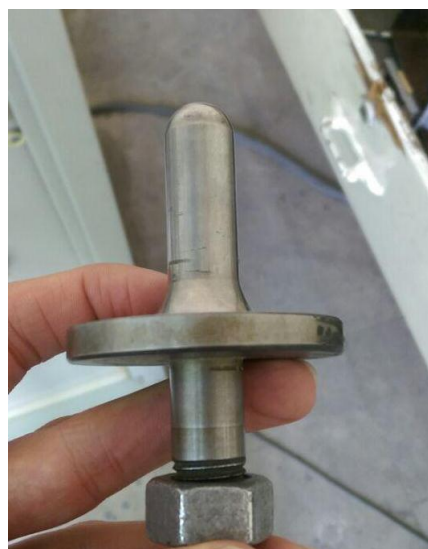
**Fig2.** Steel imp actor used in drop ball tests

The geometrical and mechanical properties of the impactor (which is depicted in Fig.2) are explained in Table 2.

Geometrical properties	Mechanical properties
Spherical part: Diameter= 16mm	Material: steel
Cylindrical part: Height 45mm	$E= 200\text{GPa}$ , $\mu=0.3$
