Study of the effect on manufacturing parameters on the fatigue behavior of aluminum engine mounting bracket

Hossein Khalajzadeh¹, Seyed Vahid Hosseini^{*1}, Alireza Shaterzadeh¹

¹Faculty of Mechanical Engineering, Shahrood University of Technology, Shahrood, Iran.

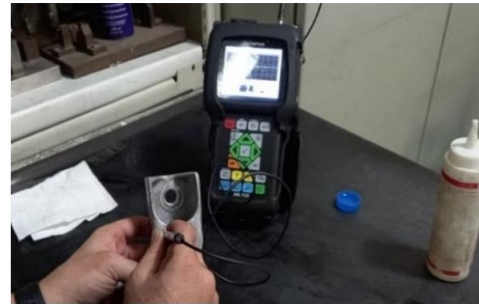
Figure 8. a) Ultrasonic thickness measurement. b) The graph obtained from the thickness measurement results of the prototype. c) Location of point 16 (Minimum thickness).
