Study of the effect on manufacturing parameters on the fatigue behavior of aluminum engine mounting bracket

The engine mounting bracket connects the engine to the car body and plays a key role in reducing vibrations and supporting the engine's weight and dynamic loads. It must be designed to withstand cyclic forces during normal use but fail safely in high-impact situations, like accidents, to minimize damage. This study examines how manufacturing parameters affect the fatigue performance of aluminum engine mounting brackets in cars. According to the staircase-Locati fatigue test results, the relative mean resistance load was measured at 1.24 with a relative scatter of 0.07, placing it in the unsafe operating region for the engine mounting bracket. To address this, a finite element analysis was carried out to identify critical areas on the part and implement modifications to enhance its performance. The crack initiation and growth regions observed during the fatigue tests aligned closely with the critical zones identified in the finite element analysis. Following the modifications and the removal of production defects, a series of experimental tests were conducted to assess the en

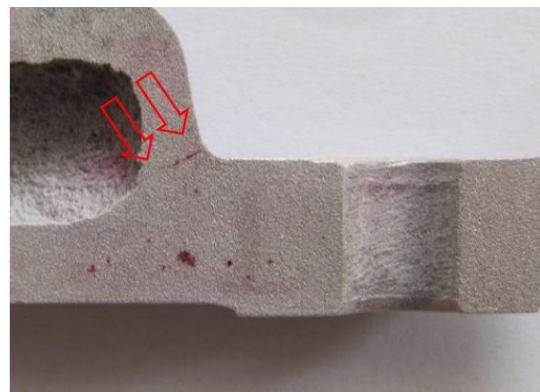
According to the ASTM E155 standard, after the machining of the part, the presence of holes up to 6 holes in the part with a maximum distance of 10 mm and a maximum depth of 2 mm cannot be the reason for failure in the part. As it is clear in Figure 6, it was observed that the crack did not occur in the connection area of the base to the wall due to the presence of a hole in this area.

Figure 6. Crack in the inner area of the connection of the base to the wall.

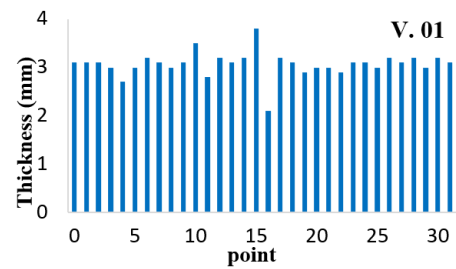
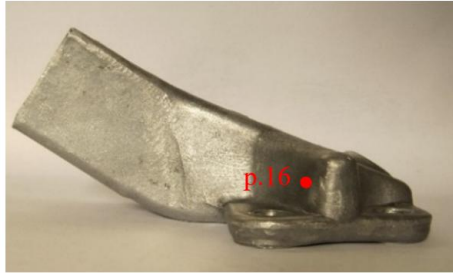
Figure 8. a) Ultrasonic thickness measurement. b) The graph obtained from the thickness measurement results of the prototype. c) Location of point 16 (Minimum thickness).
