# EFFECT OF HEAT INPUT ON THE STRUCTURE AND PROPERTIES OF ALUMINIUM WELDMENT

**Abstract:** The probable reasons for evolution of weld porosity and solidification cracking and the structure-property relationship in aluminium welds were investigated. Aluminium plates (1xxx series) were welded by Tungsten Inert Gas (TIG) welding process, 5356 filler metal was used and heat input was controlled by varying welding current (145A, 175A and 195A). The welded samples were examined under optical and scanning electron microscopes and mechanical tests were performed to determine tensile and impact strengths. Secondary phase, identified as globules of  $Mg_2Al_3$  precipitates, was found to be formed. Solidification cracking appeared in the heat affected zone (HAZ) and porosities were found at the weld portion. The tendency for the formation of solidification cracking and weld porosities decreased with increased welding current.

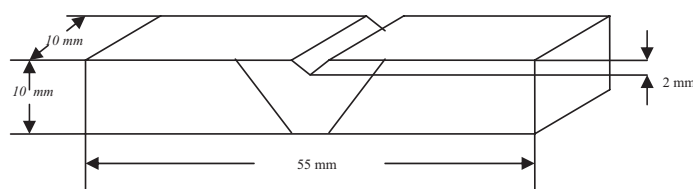
Fig. 3. Impact test specimen ( Notch at Weld centre)

Charpy impact test specimens with 2 mm deep v-notch in the weld zone, in the HAZ and in the base metal were made from each weld. A typical charpy test piece is shown in Fig.3.

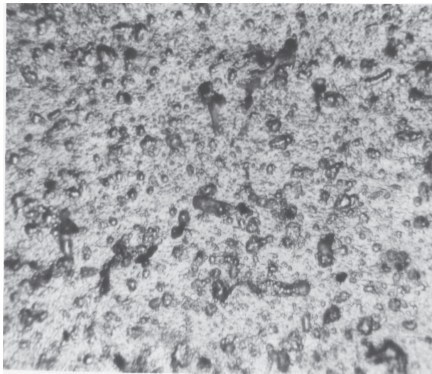
**Fig. 4(a).** Micrograph of plate 1  
( base )

The optical micrographs (Fig. 4) of these plates at weld zone, HAZ and weld root show the presence of some black globular particles.

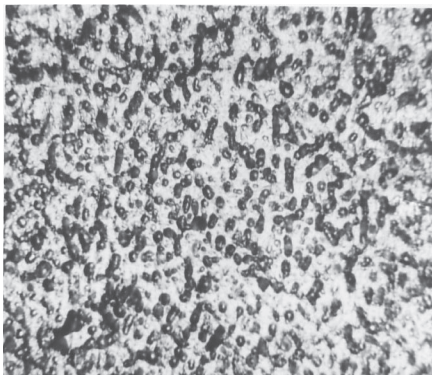
**Fig. 4(c).** Micrograph of plate 2 (root)

The  $Mg_2Al_3$  precipitates are more concentrated (Fig. 4(c)) in the weld root than in the weld portion (Fig. 4(b)). This is because of higher rate of heat dissipation at the root of the weld. During

welding, root pass is performed first and during solidification of this root portion heat can dissipate from all sides. So root portion cools rapidly. But the following weld passes have slow heat dissipation rate. Because during those passes, root and base metal are already preheated that slows down the cooling rate.

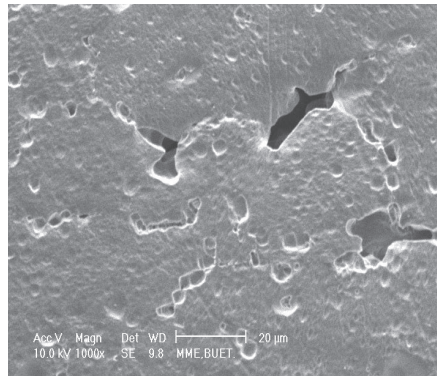
**Fig. 6(a).** SE image of plate 1

**Fig. 6(b).** SE image of plate 2

**Fig. 6(c).** SE image of plate 3

The scattered electron (SE) (Figure 6) and corresponding backscattered electron (BSE) images (Figure 7) of plates 1,2 and 3 show the presence of porosity. Gas dissolution in liquid is higher than in solid. Liquid to solid transformation rate increases with an increase in the solidification rate. As a result more gas is entrapped in solid and causes more porosity. It was found that for higher heat input (plate 3) this porosity was the minimum in quantity. This may be attributed to the fact that as heat input increases during welding, solidification process slows down, decreasing the formation of porosity [7]. Whereas at low heat input, solidification

process is very fast as a result, plate 1 and 2 show the presence of excess porosity than plate 3.

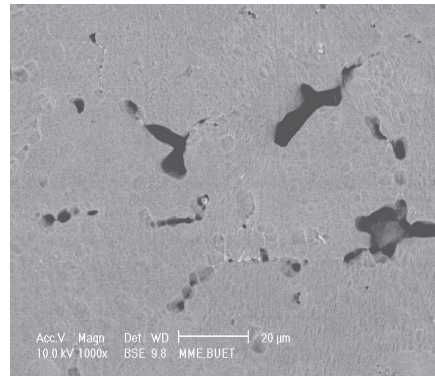
**Fig. 7(a).** BSE image of plate 1

**Fig. 7(b).** BSE image of plate 2

**Fig. 7(c).** BSE image of plate 3

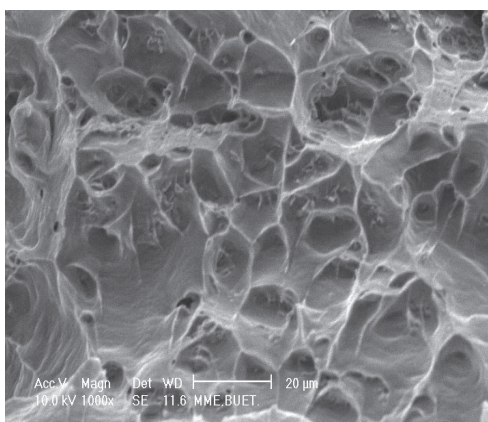
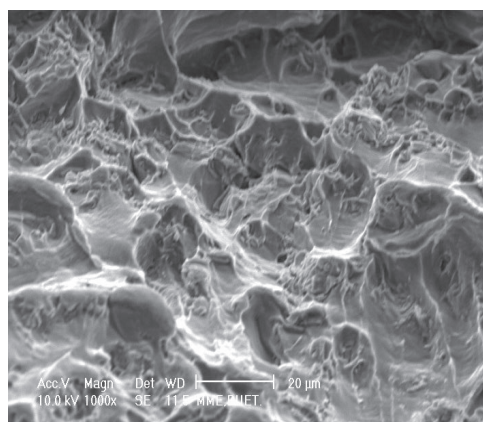
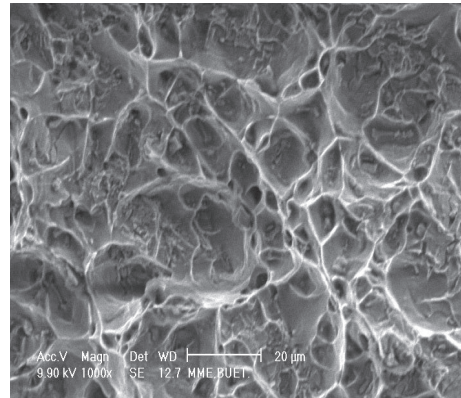
**Fig. 8(a).** Fractograph of plate 1  
( notch at weld portion)

**Fig. 8(b).** Fractograph of plate 1  
( notch at HAZ)

**Fig. 8(c).** Fractograph of plate 3  
( notch at weld portion)

**Fig. 8(d).** Fractograph of plate 3  
( notch at HAZ)

HAZ of these plates (Fig. 8(a, b,c, d)) show dimple features. The micrographs of these plates at the weld portion and HAZ showed the presence of porosity and liquefaction cracking. This preexistence of porosity and liquefaction cracking accelerates the separation of metals during impact, resulting in decrease in impact energy than the pure aluminium plate (Table 4). On the other hand the fractured surface of the base plate (figure 8(e)) show faceted features that causes brittle fracture.
